XI.E. Elevator Trim Stalls

About: Occurs when full power is applied to an airplane configured with excessive nose-up trim. Positive control of the airplane is not maintained, resulting in a stall.

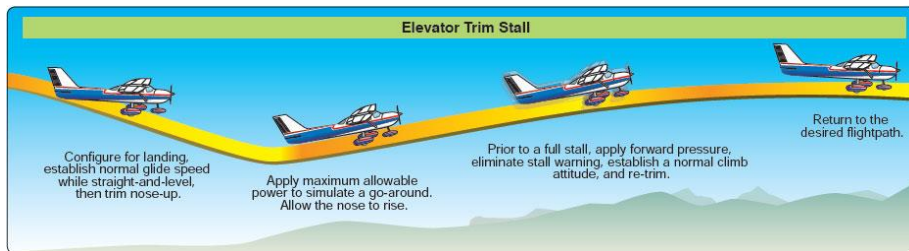
8. When pitch attitude increases above normal climb attitude and stall is imminent, apply forward pressure to yoke
9. Hold airplane in normal climb attitude and adjust trim to relieve pressure
10. Level wings with coordinated aileron and rudder
11. Retract flaps in increments as airspeed reaches V_y

12. In the event of a go around, as maximum power is applied, the nose will rise sharply and turn left
 - a. The combined effect of nose high trim, and increased prop wash over the tail and elevator tend to make the nose rise sharply
 - b. Torque and the left turning tendencies make the aircraft turn to the left
 - c. If uncontrolled, the excessive nose-up pitch can result in a stall
